20-251E

September 12, 2003

Re: **World Trade Center**
New York, New York

One World Trade Center

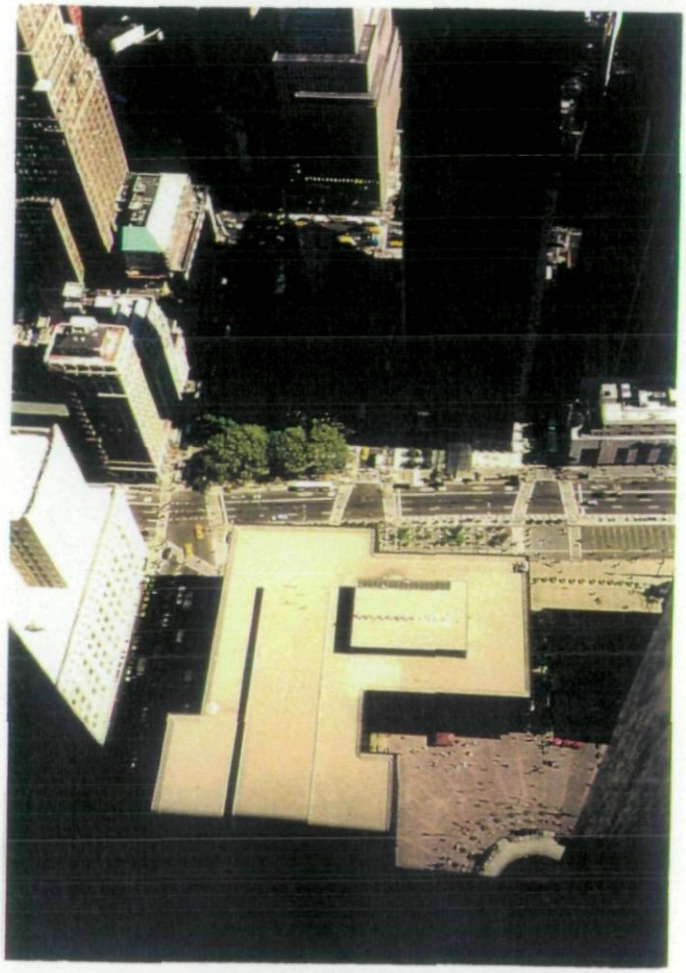
Photograph 11

Roof layout overview from tower

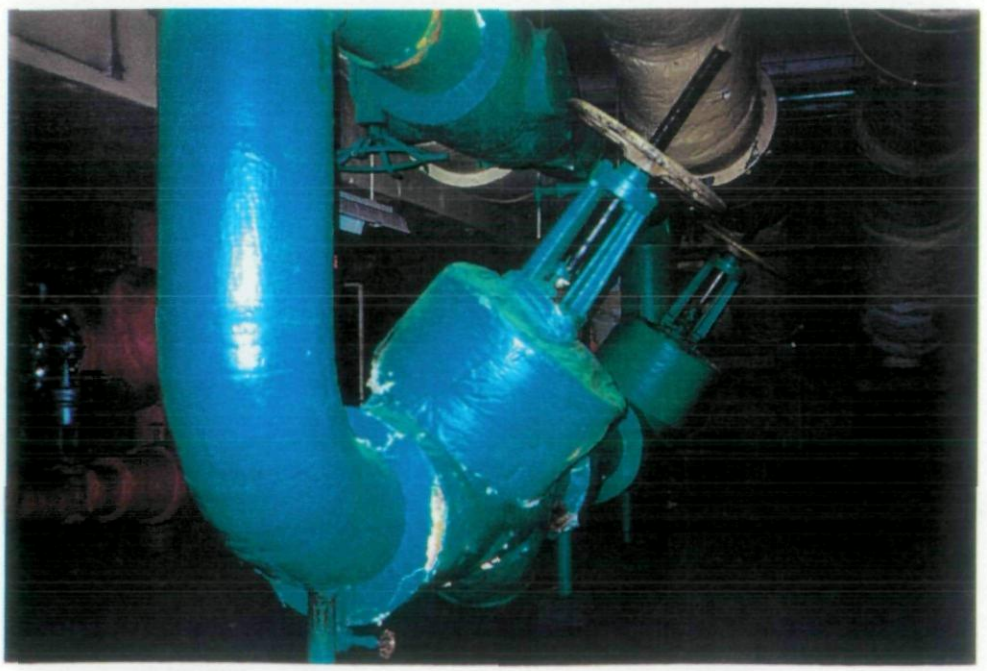
Photograph M2

Chilled water supply line from the central plant

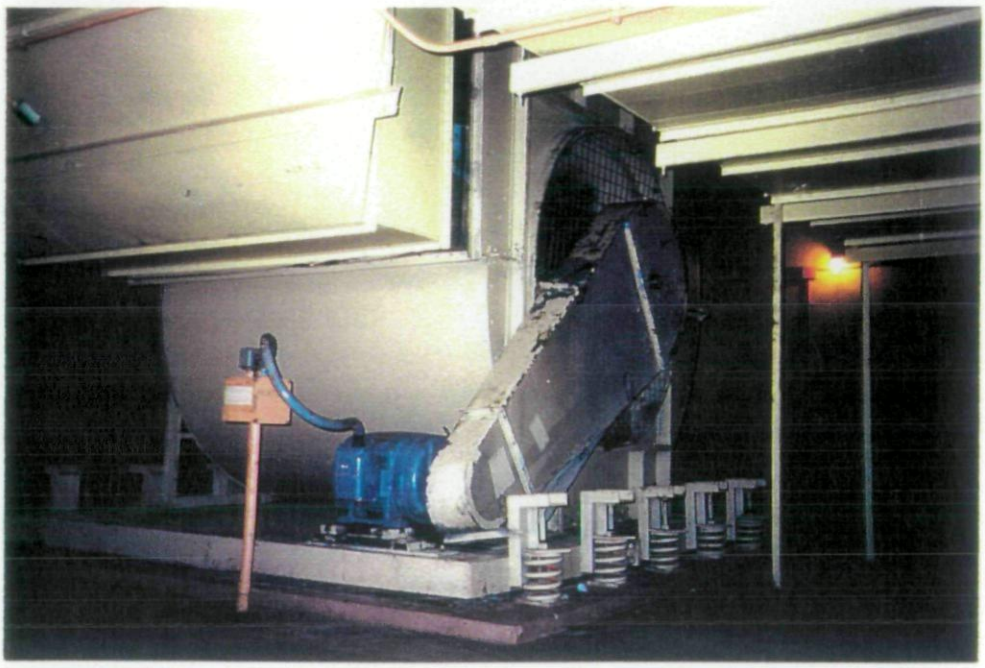
Photograph M3

Typical return air fan located in the 9th floor mechanical room

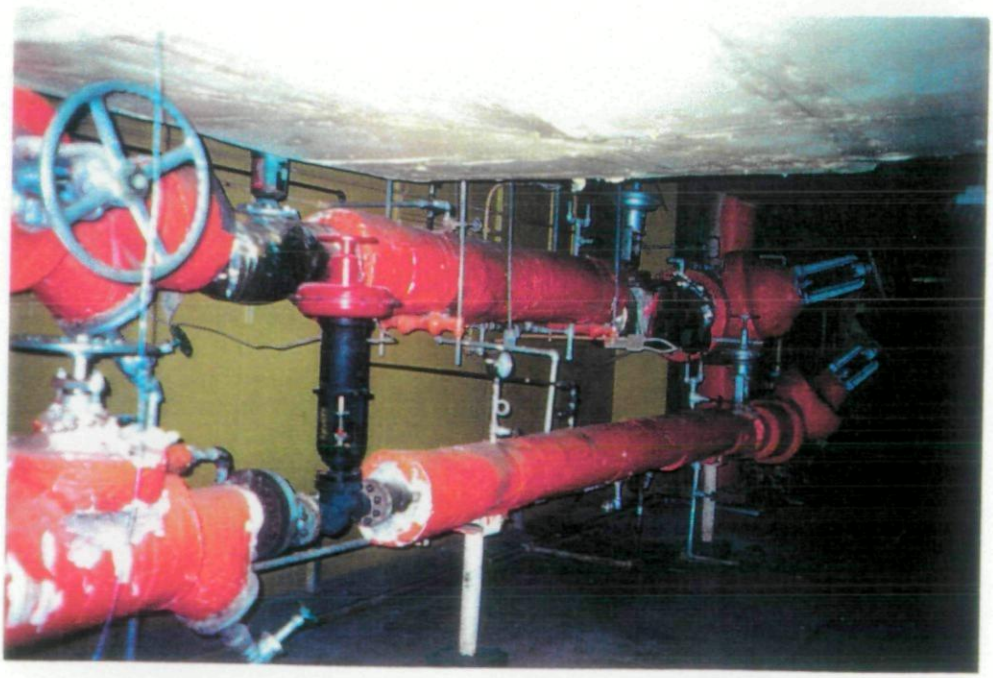
Photograph M4

Steam pressure reducing station

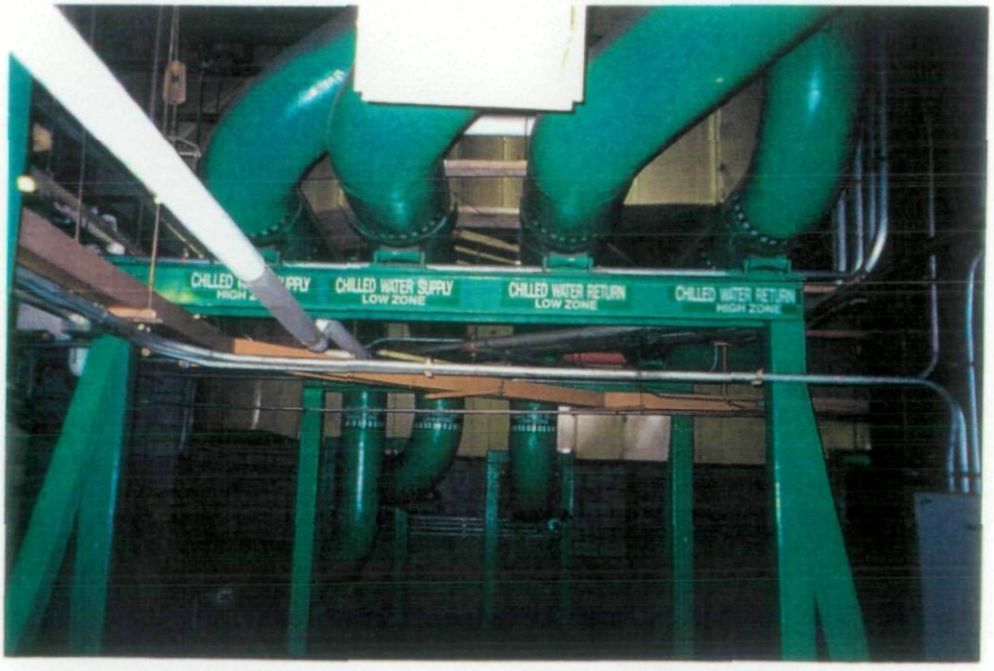
Photograph 8

High and low zone chilled water piping

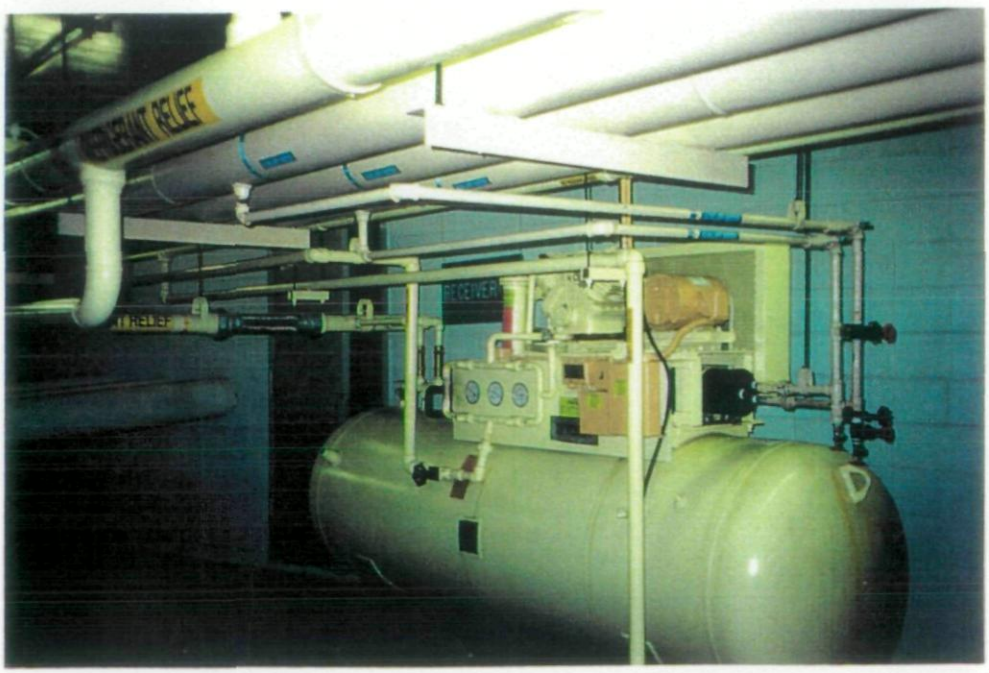
Photograph 10

Refrigerant storage tanks

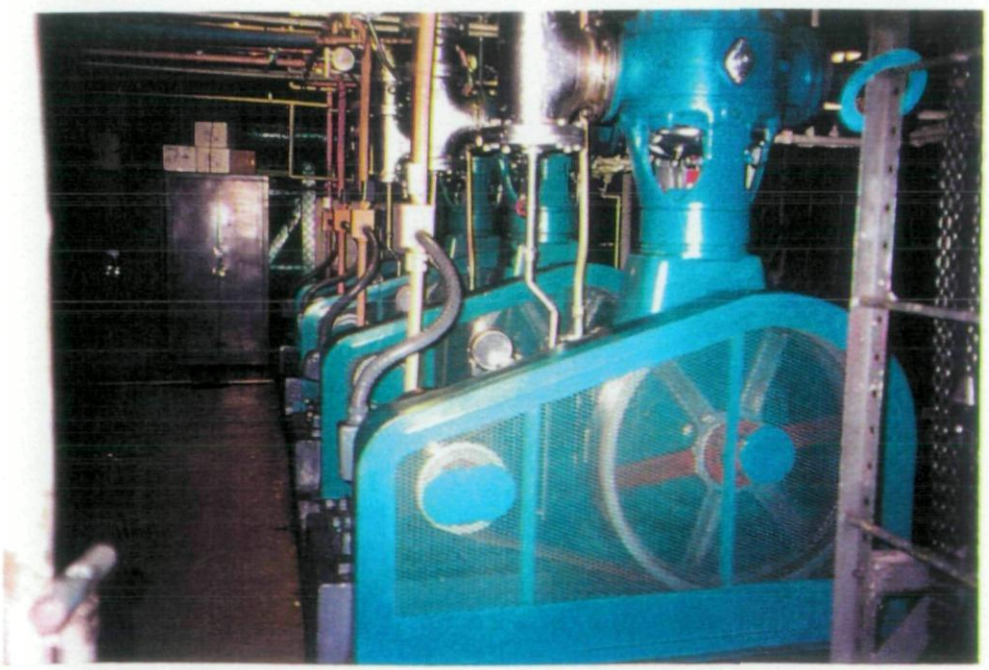
Photograph 12

Pneumatic control air compressors

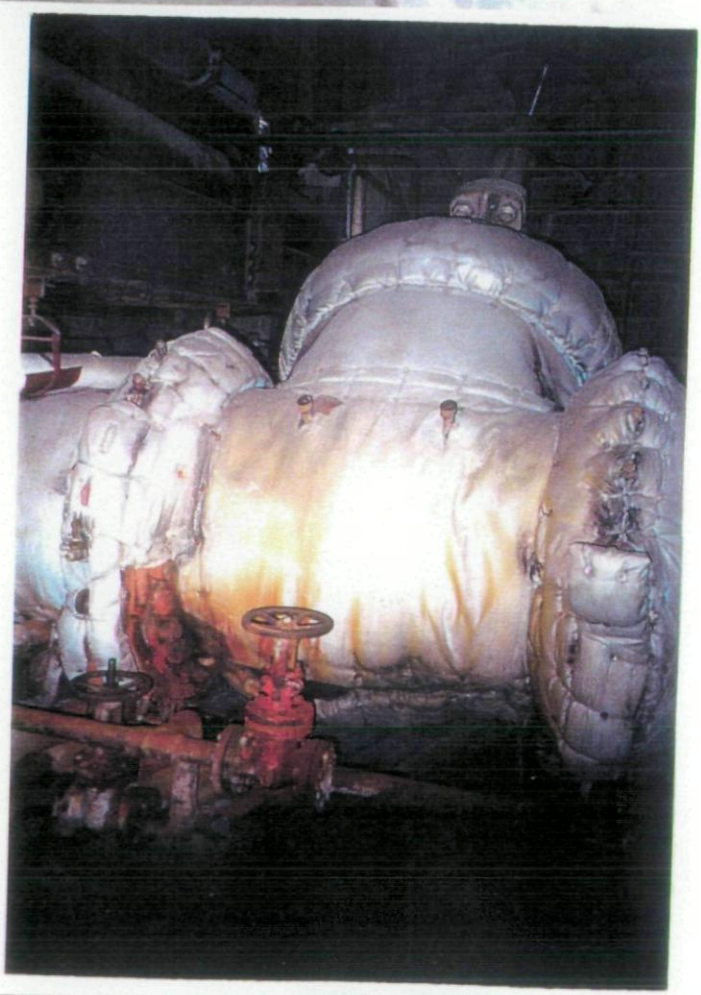
Photograph 14

Steam service valve (planned for replacement)

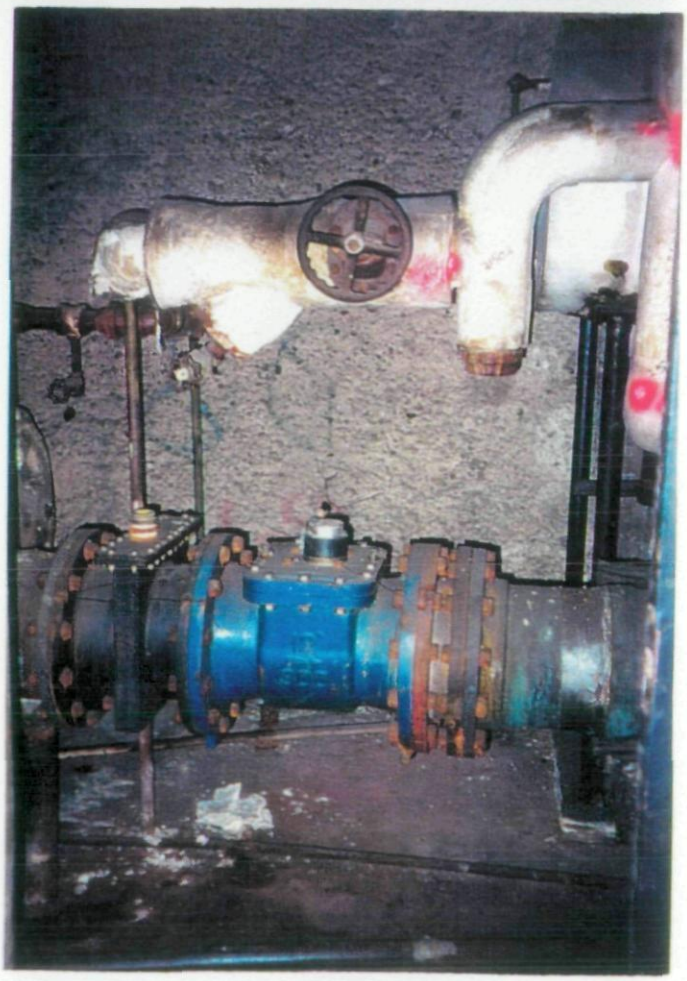
Photograph 15

Steam distribution plant

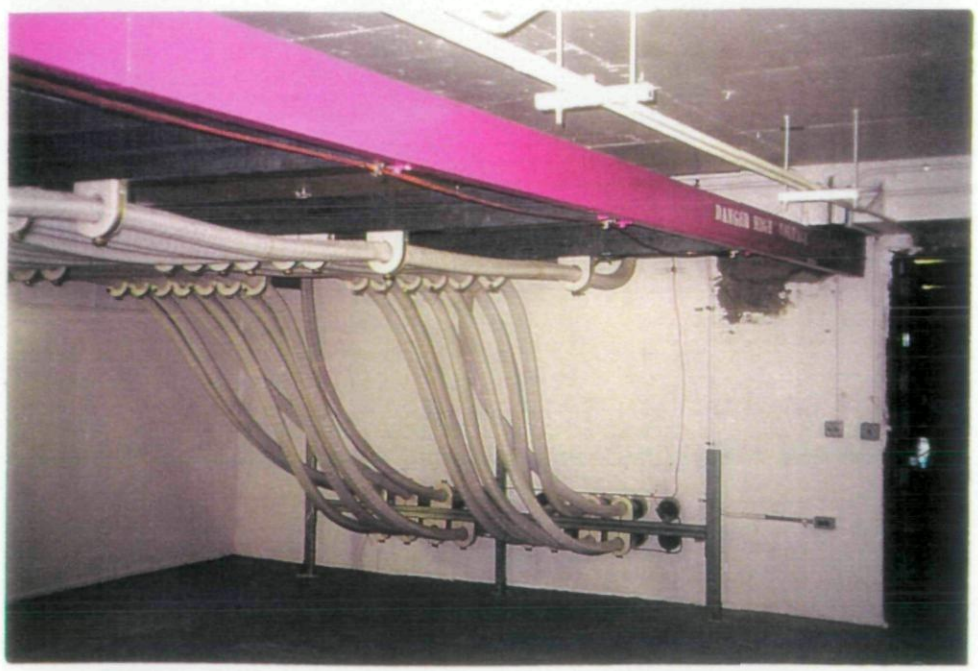
Photograph 17

Switchgear within the Primary Distribution Center

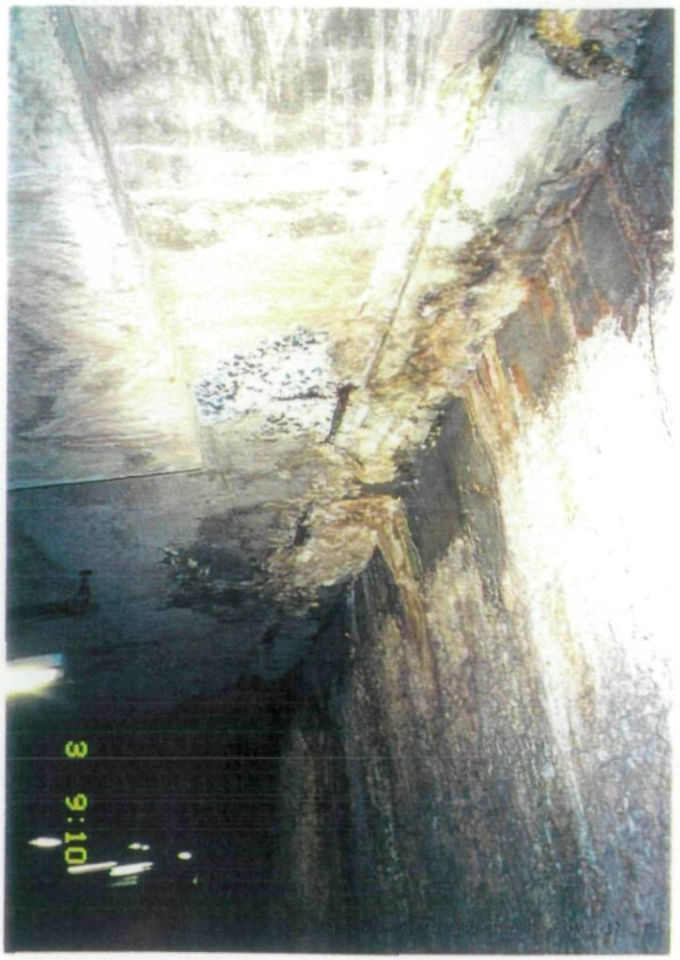
Photograph 3

Ceiling slab spalling at slurry wall

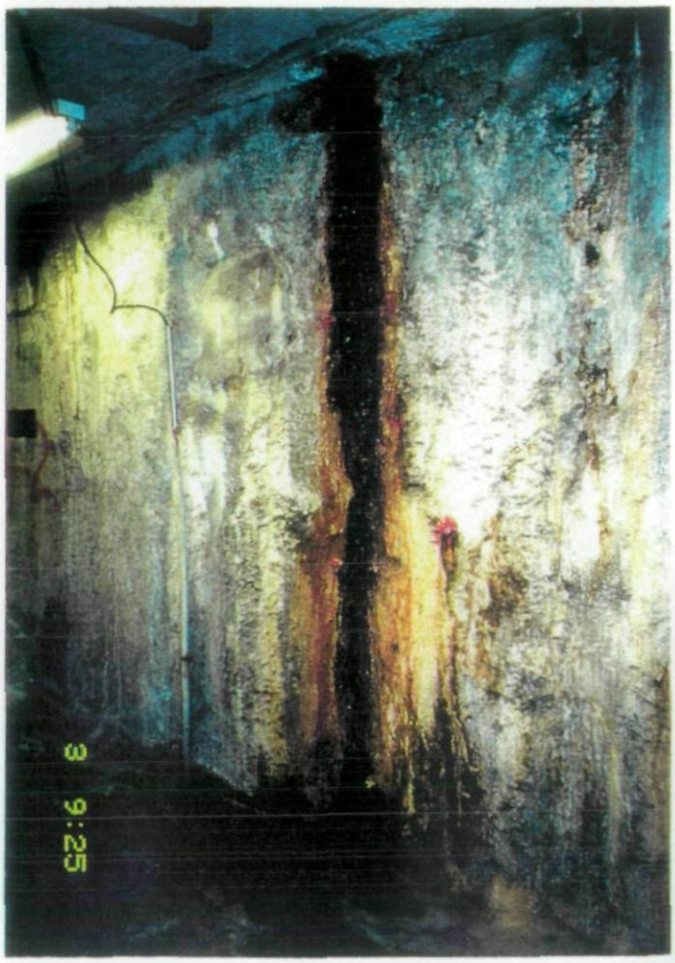
Photograph 5

Leakage stains on slurry walls

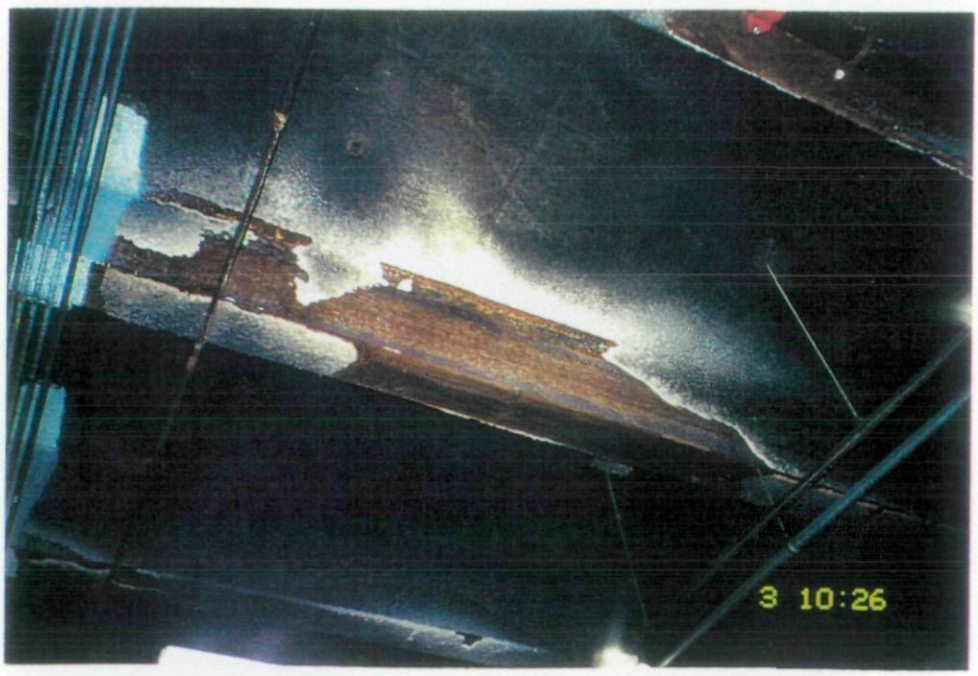
Photograph 12

Missing fireproofing at loading dock

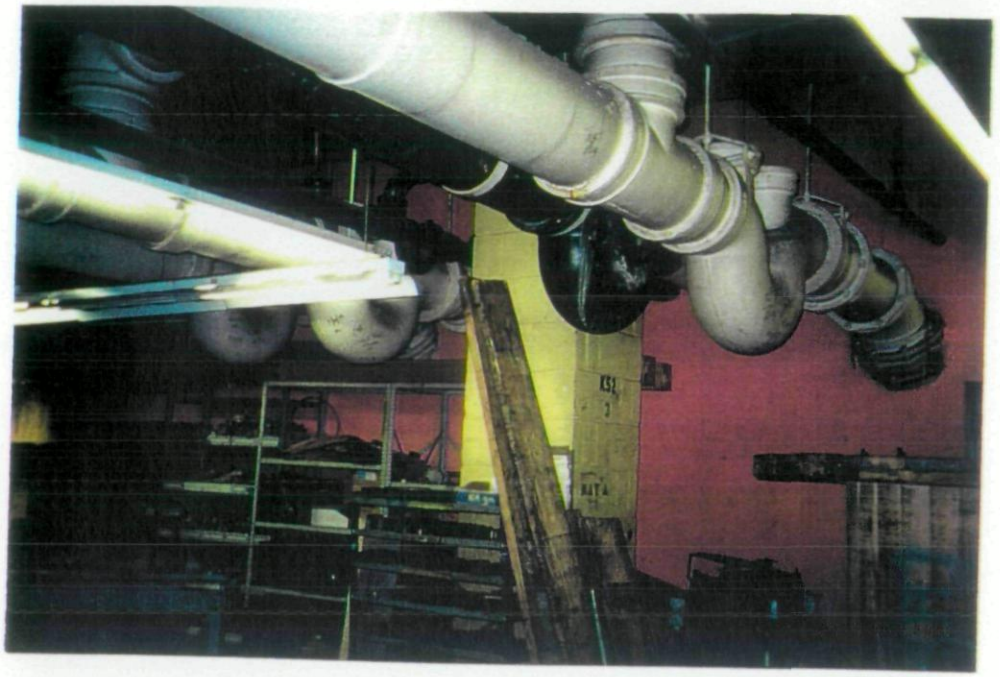
Photograph M10

Pumps within an ejector pit

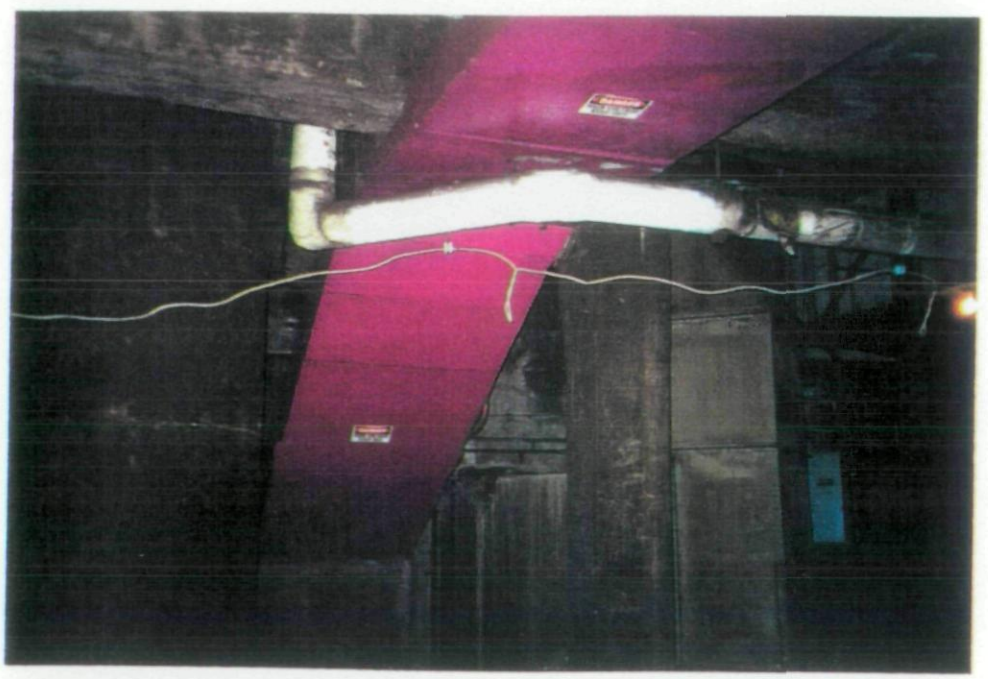
Photograph M11

House traps within subgrade space
